**PRINCES HIGHWAY WEST DUPLICATION:
WAURN PONDS TO WINCHELSEA
DESKTOP AND STANDARD ASSESSMENT
ONLY**

Name and Location of Activity: Princes Highway West Duplication: Waurn Ponds To Winchelsea

Sponsor: VicRoads

Report Date: 6/2/2009

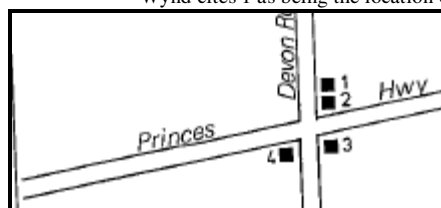
Figure 1 Detail from Figure 5.7 in Wynd 1992: 83, showing the approximate location of places mentioned in the text. Wynd cites 1 as being the location of the Store 2. Clifford Hotel 3. Church of England 4. Smithy

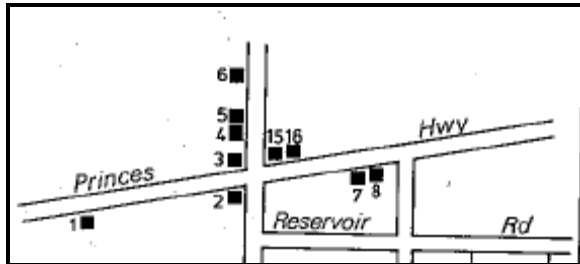
Figure 2 Detail from Figure 5.8 in Wynd 1992: 84, showing the approximate location of places near the Princes Highway Activity Area. Wynd refers to 1. as being the location of the St. Patricks Church., 2. Duneed/Mount Moriac Hotel 3. Smithy 4. Shire Hall 5. Church of England 6. Bible Christian Methodists Chapel 7. Police Barracks 8. Mount Moriac State School 15. Hall 16. Store

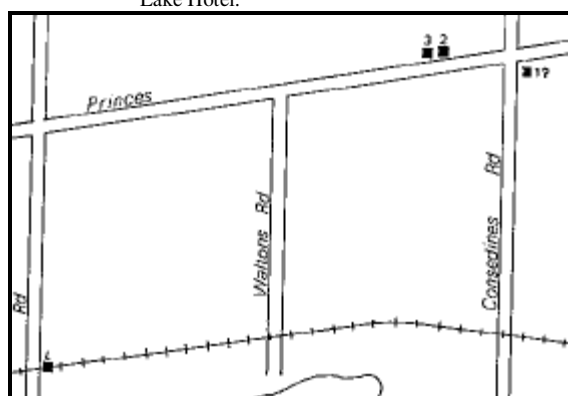
Figure 4 Detail from Figure 5.11 in Wynd 1992: 94, showing the approximate location of places mentioned in the text. Wynd cites 1 as being the location of the Mount Moriac National School, 2. Laketown School and 3. Lady of the Lake Hotel.

The features are also described in Wynd's brief history of Barrabool (1992: 94, Figure 2), including the Lady of the Lake Hotel (1854, destroyed by fire in 1965). The Hotel is likely to have been situated just north of the Princes Highway (Figure 4).

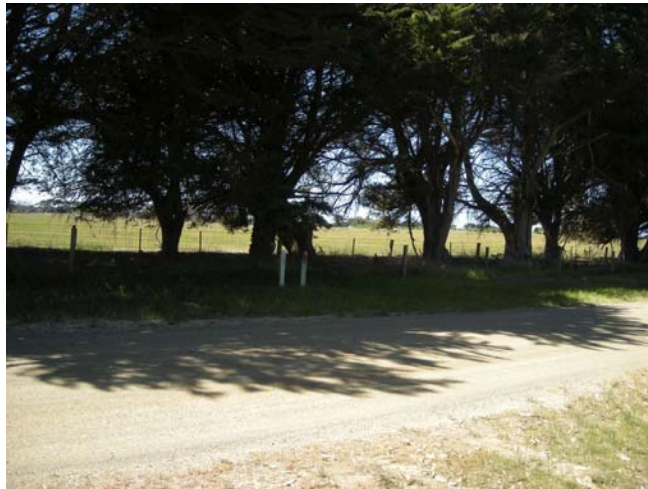
Plate 1 Typically good visibility near roadways, Cape Otway Road

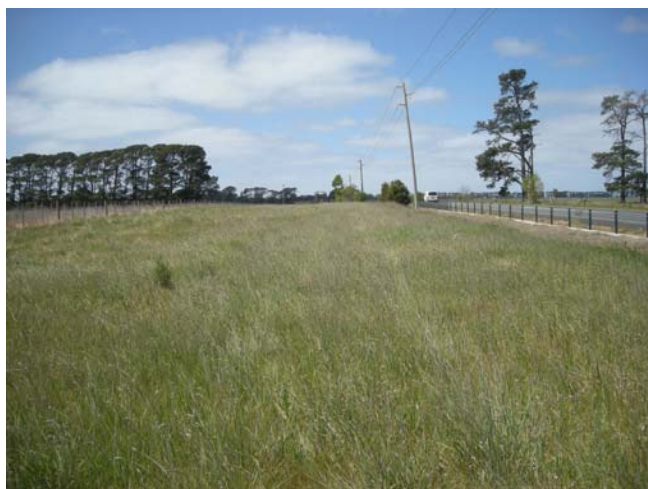
Plate 3 Typical visibility in road reserves; note the long grass

Apart from this, the majority of the Activity Area was found to be either under crop (private allotments), or covered by long grass (road reserves) and visibility was therefore generally poor. Visibility was best close to the roadways, at intersections and across drive-ways, but these sections were found to be highly disturbed and generally contained imported fill which was easily identified.
